Environmental Application CPT Technology Case Study—Kansas

Lorraine M. LaFreniere, Ph.D.
Argonne National Laboratory
Applied Geosciences and Environmental Management
Environmental Science Division

Case History—Kansas CCC/USDA Former Grain Storage Facility in Operation from the 1950s to early 1970s

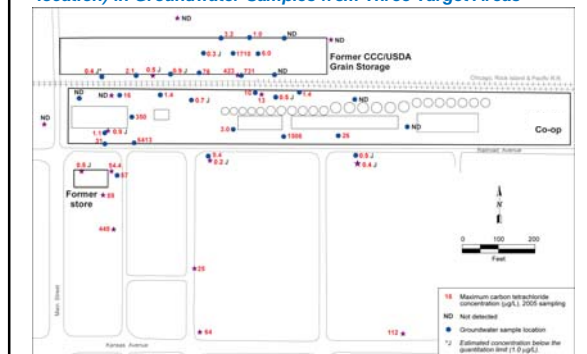
9

Carbon Tetrachloride Concentrations (maximum at each location) in Groundwater Samples from Three Target Areas
